TBI-Report-Example 7.10

TBI-Report

TBI-Report-Example 7.10 Result at a glance

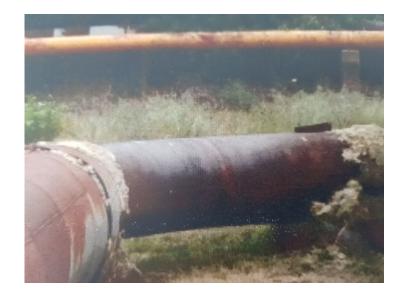
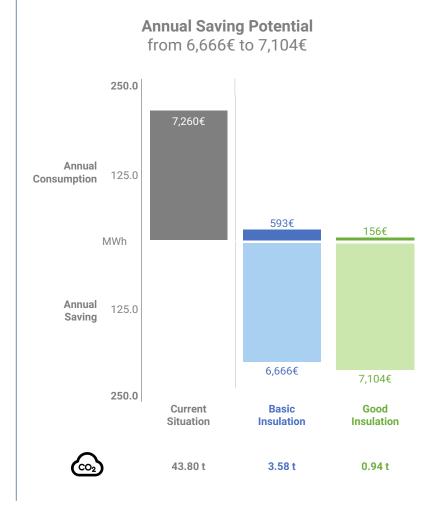
Pipe 1 / outside: Uninsulated pipe

Surface temperature (°C) 250

Component/Location Pipe 1 / outside CO₂ emission factor (grCO₂/kWh) 181 Length (m) 3 Surface material

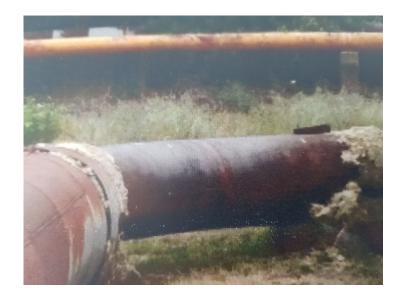
Pipe 1 / outside: Hot Surface

Comments Hot Surface Component/Location Pipe 1 / outside

Surface temperature (°C) 250

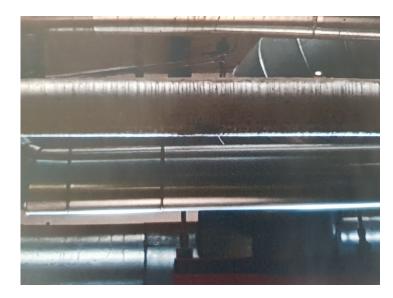
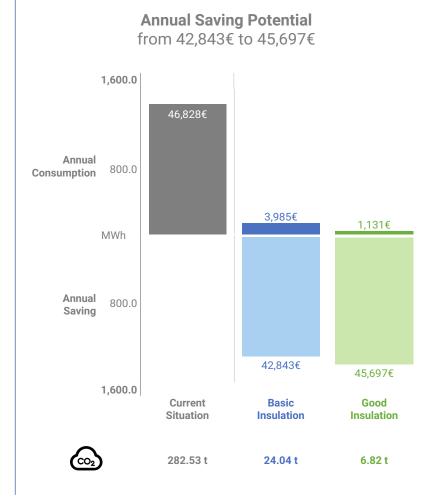
Pipe 1.2 / Hall 1: Uninsulated pipe

Medium temperature (°C) 250 (Gas)

Component/Location
Pipe 1.2 / Hall 1

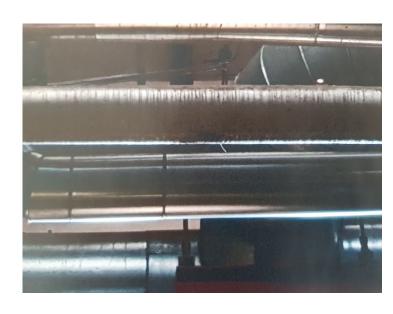
Pipe 1.2 / Hall 1: Hot Surface

Comments Hot Surface Component/Location Pipe 1.2 / Hall 1

250 (Gas)

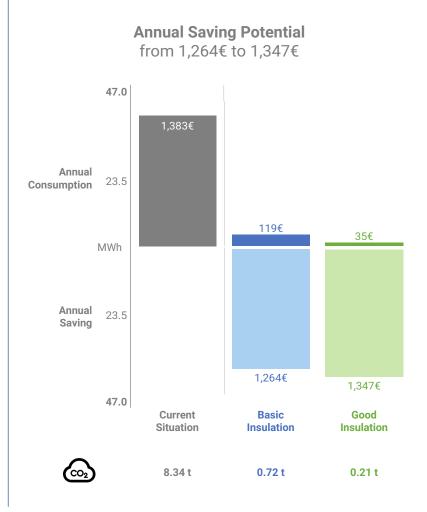
Valve 1 / outside: Uninsulated valve

Project TBI-Report-Example 7.10	
Energy cost (€/kWh) 0.03	
Diameter (mm) 323.9	
Operational time 8760	
Surface temperature (°C) 260

Component/Location Valve 1 / outside
	CO ₂ emission factor (grCO ₂ /kWh) 181
	N° of items (m)
	Surface material General value [0.80]
	Ambient temperature (°C)

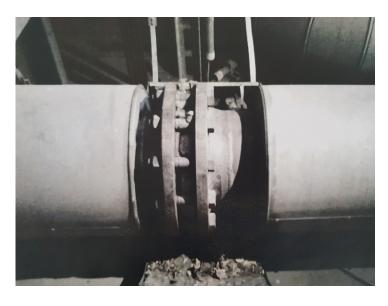
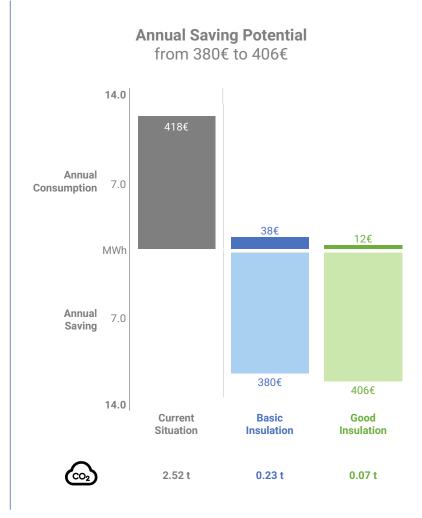
Flanges 1 / Hall 1: Uninsulated flange

270 (Gas)

Component/Location
Flanges 1 / Hall 1

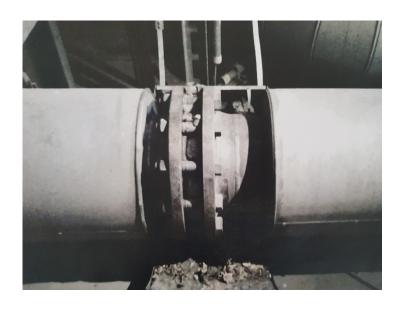
Flanges 1 / Hall 1: Hot Surface

Comments Hot Surface Component/Location Flanges 1 / Hall 1

Medium temperature (°C) 270 (Gas)

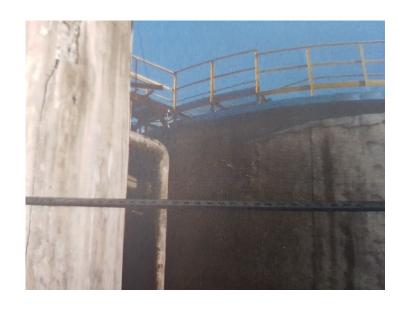
Wall Tank 2 / outside: Hot Surface

Comments Hot Surface Component/Location Wall Tank 2 / outside

Surface temperature (°C) 65

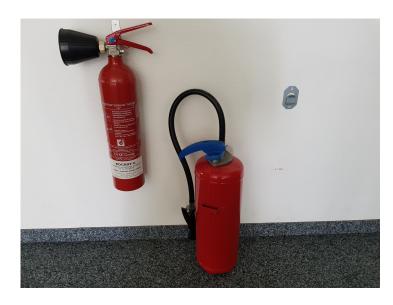
Fire extinguisher empty: Fire Protect

Component/Location Fire extinguisher empty

FE needs to be refilled and replaced.

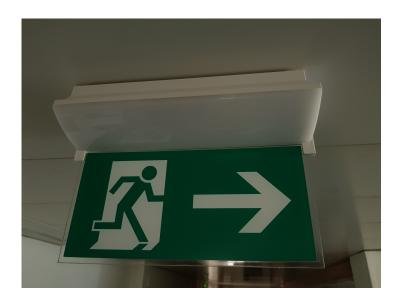
Emergency Exit Signage / inside: Fire Protect

Component/Location
Emergency Exit Signage / inside

Light needs to be repaired.

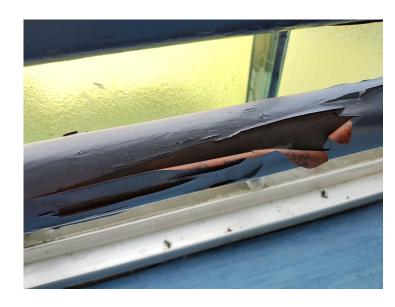
Pipe 2 / Bridge: Damaged

Damaged

Needs to be re-painted: Corrosion

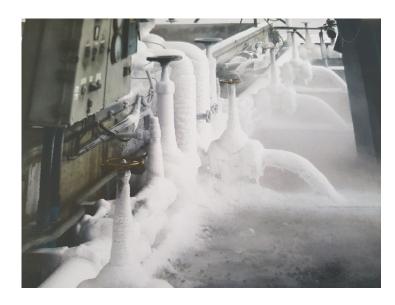
Pipe 3 + Valves Combi.: Condensation

Condensation Ice block

Valves are blocked, pipe heavily iced etc.

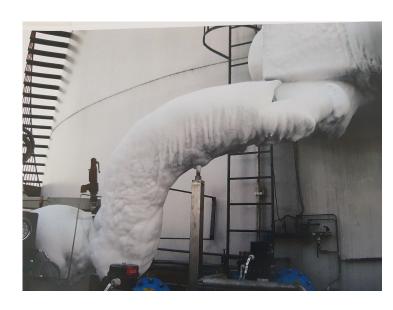
Ellbow 1 / outside Tank 2: Condensation

Ice getting too heavy

Condensation Ice block

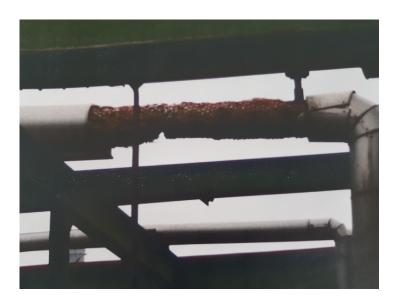
Pipe 4 / outside: Damaged

Damaged cladding Lack of cladding

Missing cladding leading to wet insulation: Corrosion risk + energy waste

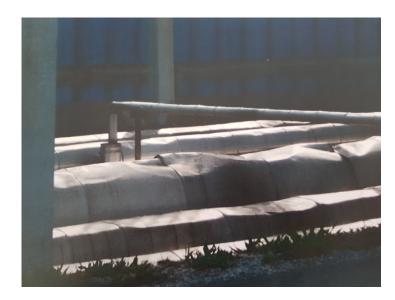
Pipes 5-10 / outside: Damaged

Damaged cladding

Foot traffic/Dent

Water ingress due to damaged cladding: Corrosion risk + energy waste
